SLEEP WELL HOME INSPECTION SERVICES LLC

RESIDENTIAL HOME INSPECTION REPORT

1234 Main Street
Waynesville, NC 28785

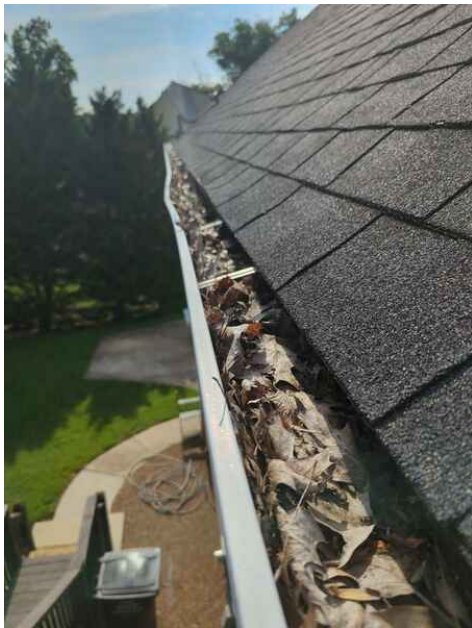
Rear Gutter System

Some roof drainage system downspouts appeared to have blockages leaves j in gutters. This condition can cause gutters to spill, resulting in excessively high soil moisture levels with the potential to cause foundation damage related to soil movement. Blocked downspouts should be cleared, and gutters kept clean to avoid future blockages.

Contact a handyman or DIY project

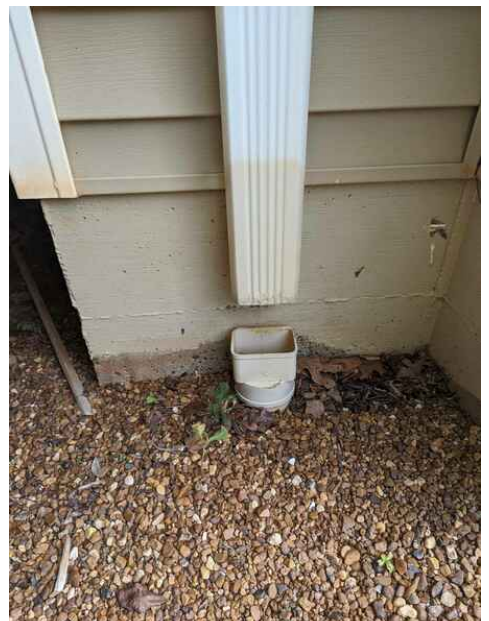
Some roof drainage system downspouts disconnected. To avoid possible foundation damage that can result from excessively high soil moisture levels, disconnected downspouts should be re-connected

Missing Boot connecting downspout to drainage system. Located beside front porch.

Recommended DIY Project

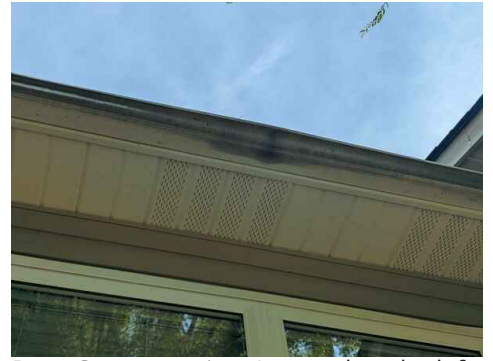
The gutters were bent or damaged. Damaged gutter sections should be replaced by a qualified contractor to avoid excessively high moisture levels in soil near the foundation that can cause foundation damage related to soil movement.

Bent Gutter section. Located to the left of the front porch.

Contact a qualified gutter contractor

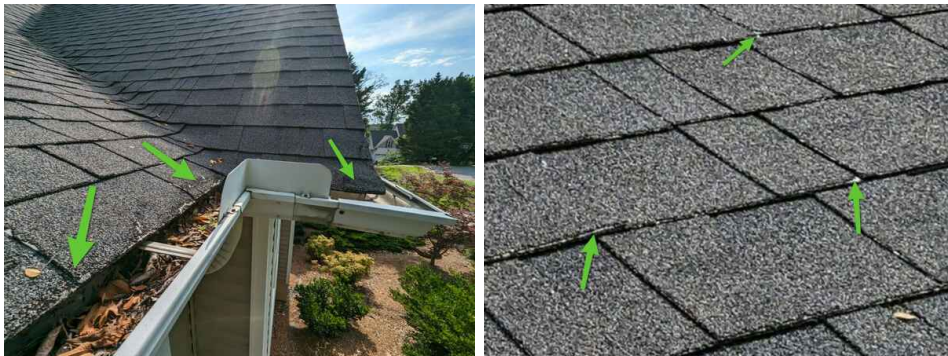
The architectural asphalt shingles exhibited moderate deterioration on edges of shingles. Fiberglass mat edges will breakdown faster when exposed to the elements but it will not immediately affect their ability to protect the structure. Recommend monitoring for possible leaks and contacting a Roofing Professional when necessary.

Granular loss along edges of some shingles

Contact a qualified roofing professional.

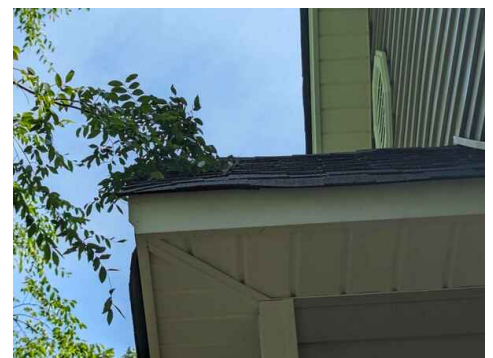
Tree branches were rubbing against the roof of the fireplace bump out roof. Continued growth from tree will eventually damage the house. Recommend pruning trees back away from structure.

Contact a qualified tree service company.

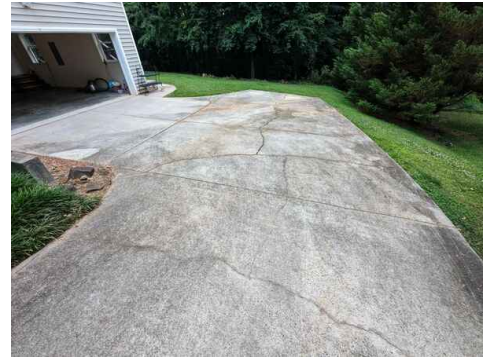
Significant cracks (greater than 1/4 inch (6 mm) in the driveway surface should be filled with an appropriate material to avoid continued damage to help reduce continuing damage.

Contact a qualified professional.

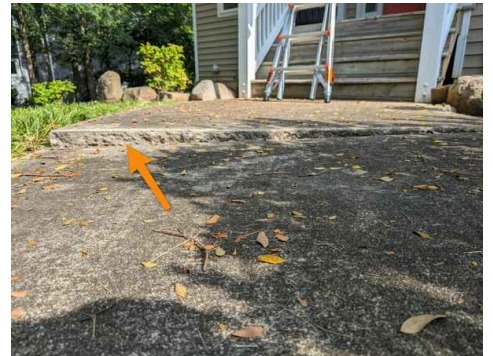
Vertical soil movement beneath walkway pavement in areas has created trip hazards that should be corrected by a qualified contractor for possible mud jacking.

Contact a qualified professional.

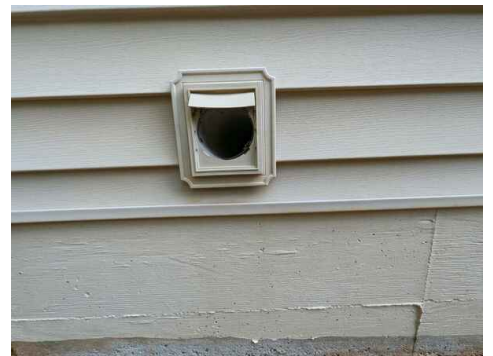
Where it discharged to the home exterior, the dryer exhaust duct was missing the cover or screen. This condition may allow animal entry or the accumulation of debris related to animal nesting, a potential fire hazard. A proper cover should be installed by a qualified contractor.

Missing or Broken Louvers on dryer exhaust vent in front of house

Contact a qualified professional.

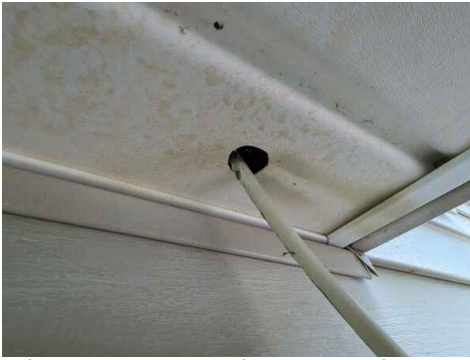
Exterior wall penetrations had gaps that should be sealed with an appropriate sealant to prevent moisture and insect entry.

Where propane gas line enters the house should be caulked.

Contact a qualified handyman.

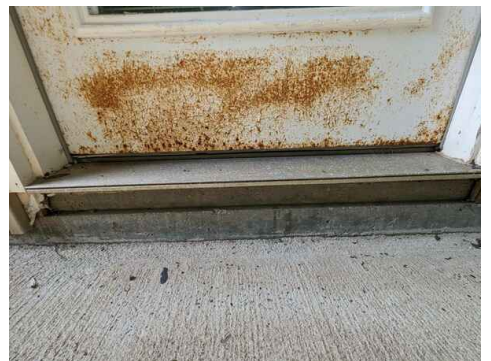
The rear exit door to the patio has damage to the bottom portion appears to be rusted. Recommend painting or repairing the finish to prevent more rust from forming.

Recommended DIY Project

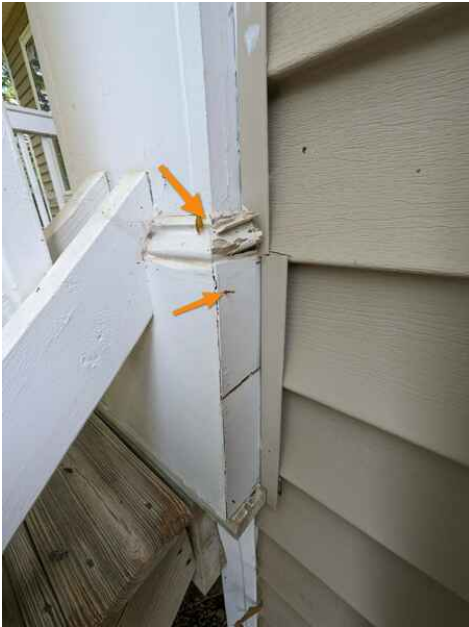
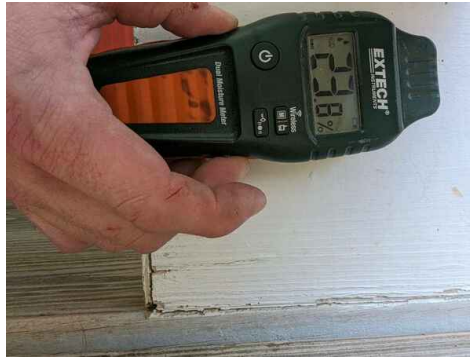
Moisture damaged wood and a loose trim nail show signs of previous water intrusion.

Contact a qualified professional.

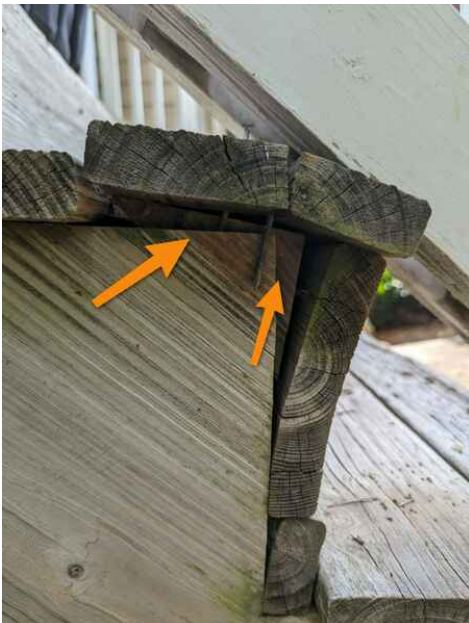
Corner of Stringer is broken loose and step is pulling away.

Contact a qualified carpenter.

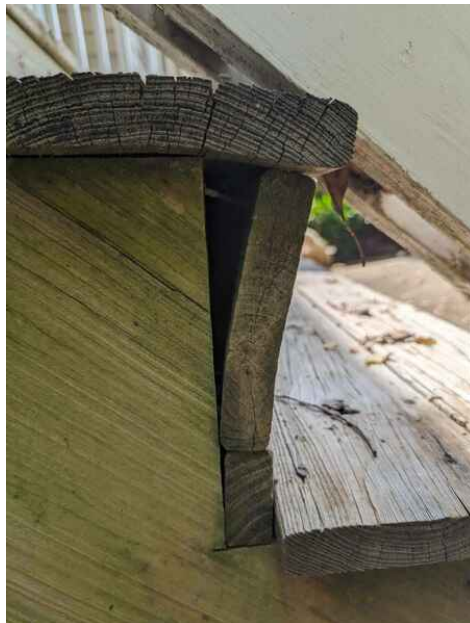
Step Pulling away from Stringer

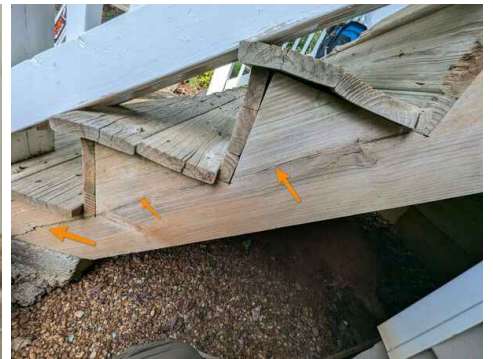
Continuous Crack running full length of right side stringer

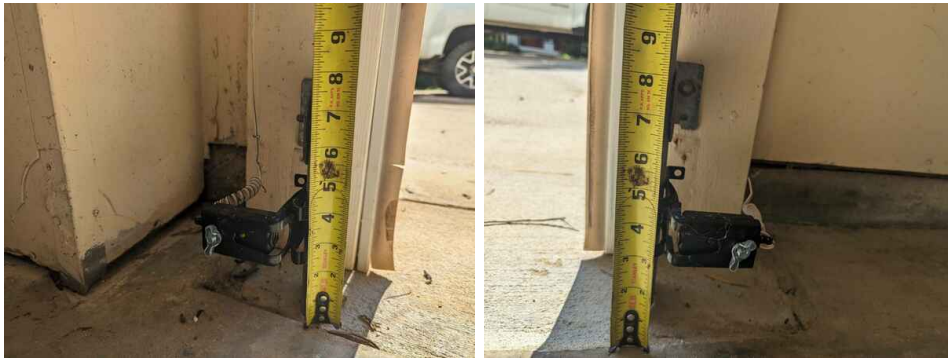
Center of Photo-Eyes should be mounted between 4 and 6 inches.

Contact a qualified garage door contractor.

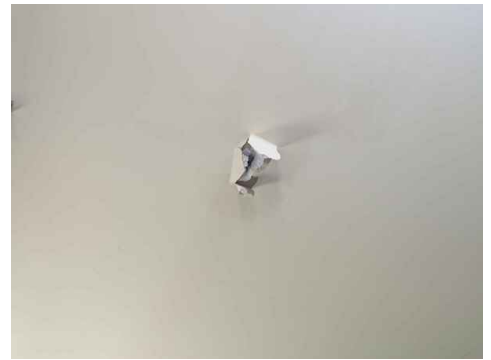
A small hole was observed in the garage ceiling. This can allow Exhaust Gases from vehicles to enter the living space. Recommend Patching and repairing of the hole to prevent future incident.

Hole in ceiling

Recommendation
Recommended DIY Project

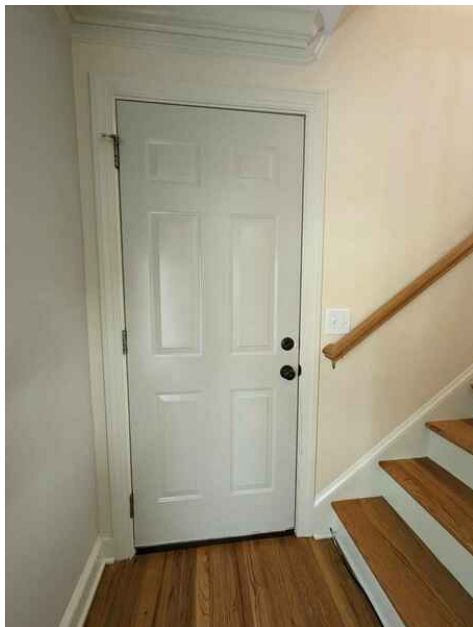
Door leading into garage does not have self closing hinges.

Contact a qualified professional.

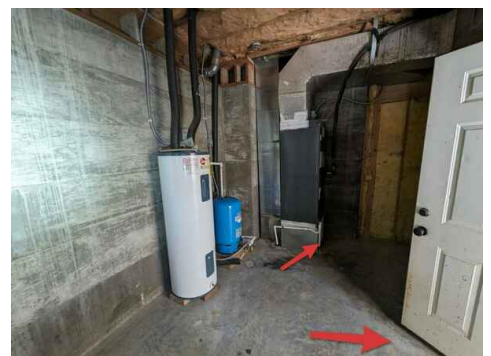
AIR INTAKE FOR HVAC PULLS FROM UTILITY ROOM THAT IS OPEN TO THE GARAGE.

The door to the utility room was open at the time of inspection and did not have self closing hinges installed. This can allow the HVAC system to draw in air from the garage which can draw exhaust gases from vehicles to enter the living space and cause a concern for carbon monoxide. Recommend installing self closing hinges on the door to the utility room.

Contact a qualified professional.

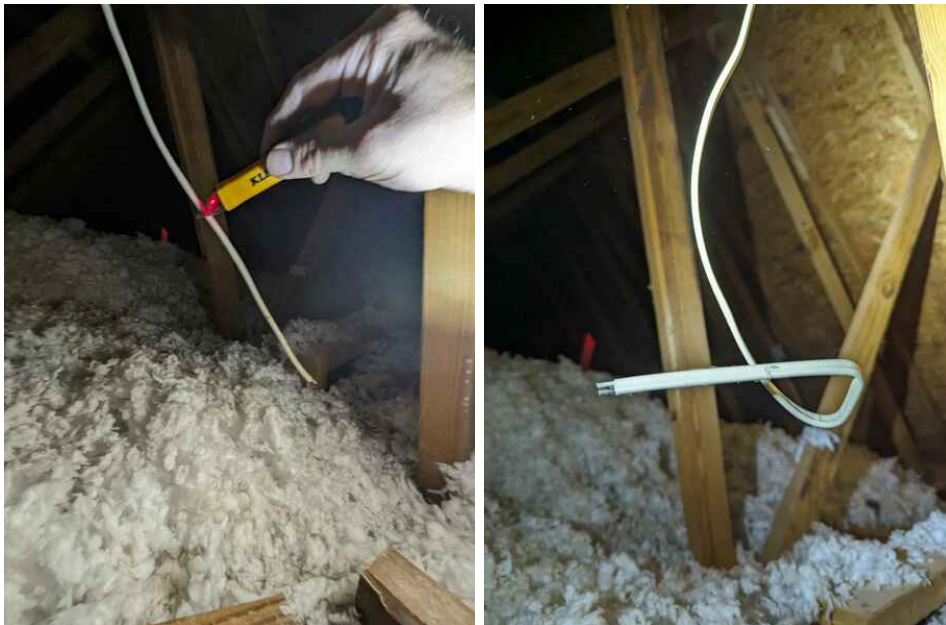
Live Electrical just inside the attic access hatch

Contact a qualified electrical contractor.

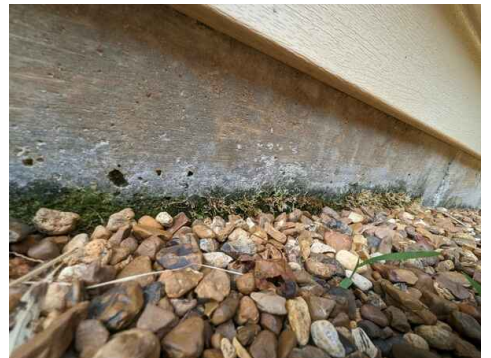
Moss growing on side of slab foundation

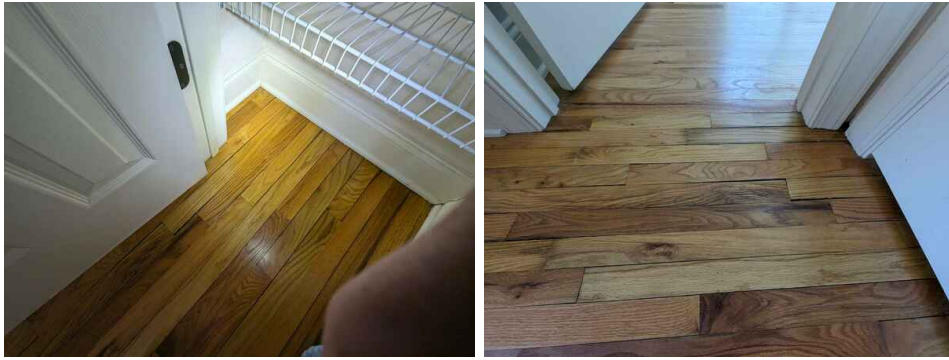
Wood flooring had areas of discoloration typical of moisture damage but the floor was not wet at the time of inspection.

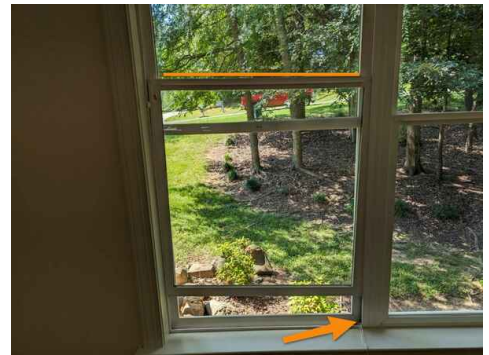
Window sash sits crooked in the frame due to broken weight.

Contact a qualified professional.

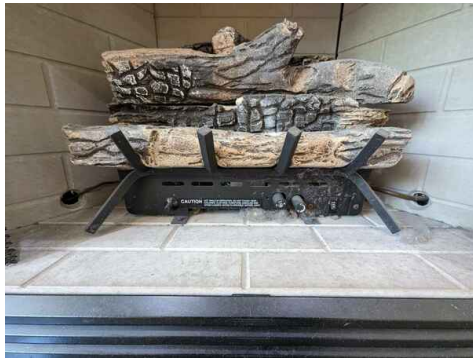
Flammable debris inside firebox

Contact a qualified professional.

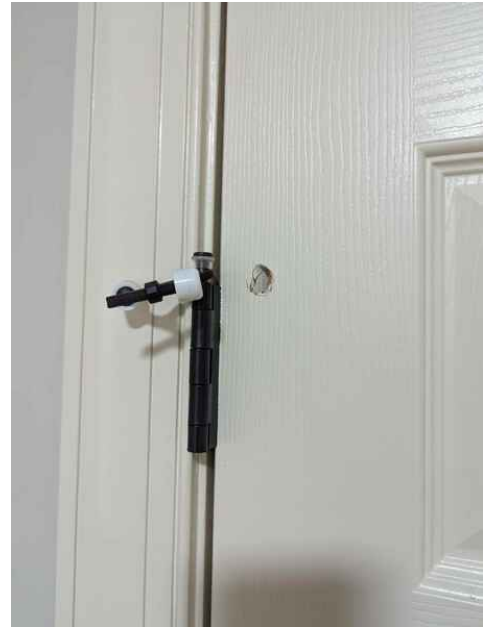
An interior door in this bedroom exhibited minor damage or deterioration. There was a hole in the closet door caused by the door stopper. Recommend patching mainly cosmetic.

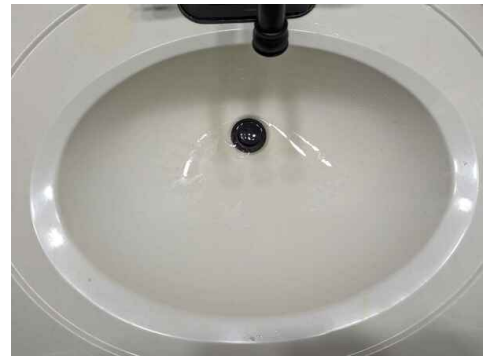
Slow Drainage

Contact a qualified professional.

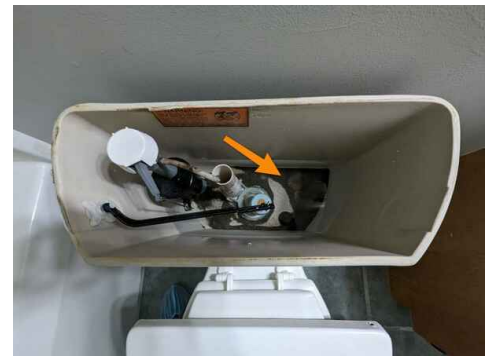
Inspector observed sediment build up in the toilet tank in the bathroom. This is due to minerals in the water such as calcium and magnesium. Sediment build up can clog the holes where water flows into the toilet bowl resulting in a weak or incomplete flush.

Recommend having a licensed plumbing contractor install a sediment filter in the home.

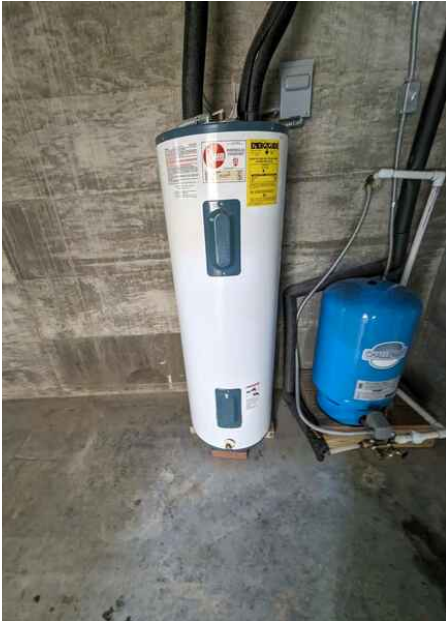
The date of manufacture for this water heater appeared to be ___November 2000___. Water heater is approximately 24 years old. It was noted that the water took a while to get to a warm temperature when testing the hot water. Even though the water heater appears to be functioning at the time of the inspection. 24 years is well beyond the recommend service life of an electric water heater. Inspector recommends budgeting for a replacement in the next 5 years.
