SLEEP WELL HOME INSPECTION SERVICES LLC

RESIDENTIAL HOME INSPECTION REPORT

1234 Main Street
Waynesville, NC 28785

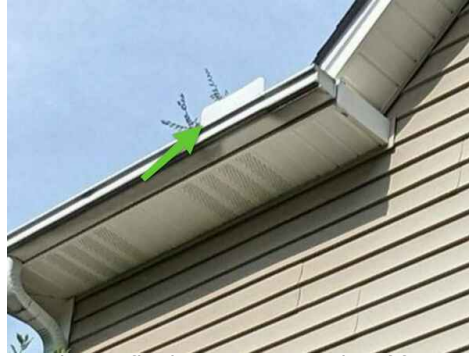
Kick out flashing garage side of front gable roof blocked by tree limb

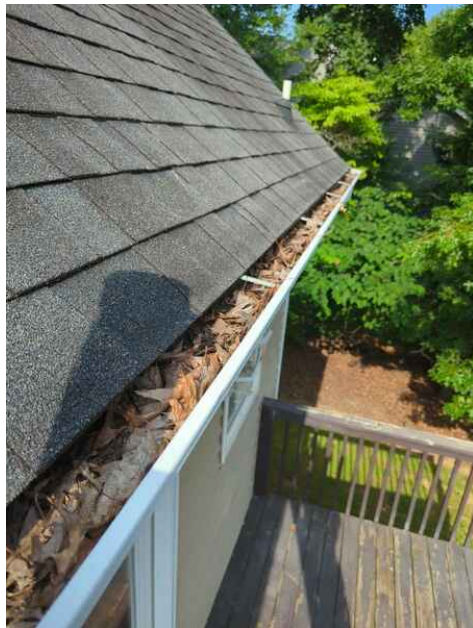
Rear Gutter System

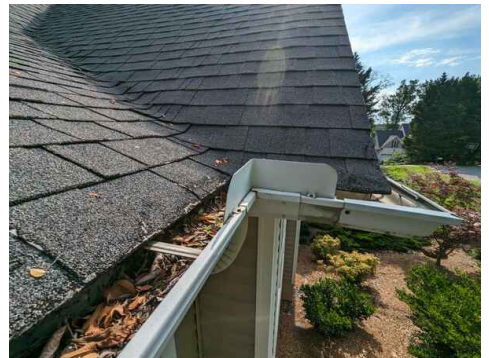
2.6.2 Roof Drainage

Rear Gutter System

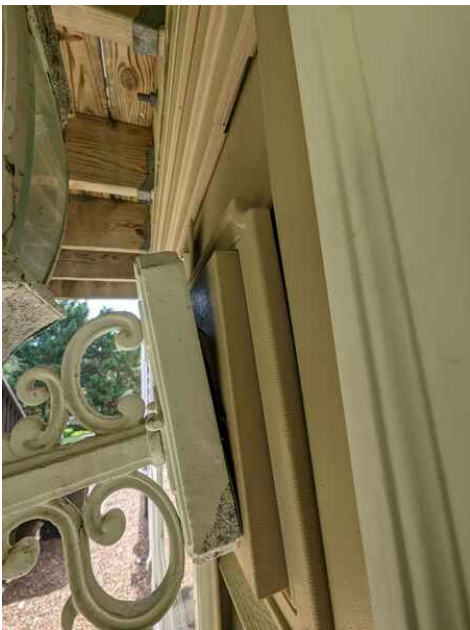
Light fixture on rear of house is pulling away from wall

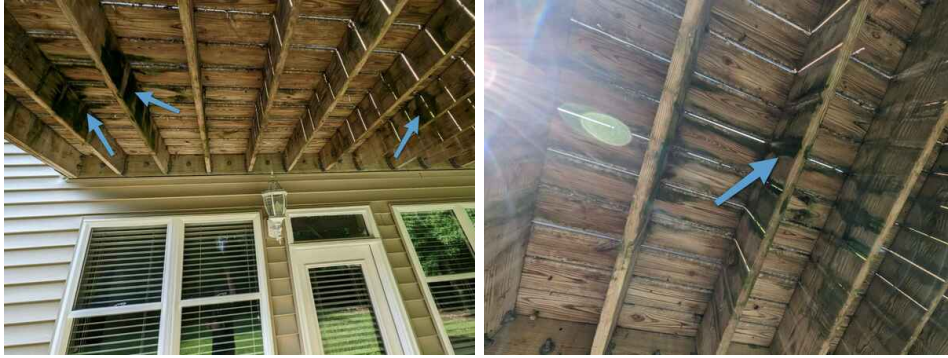
Water staining and organic growth was noted on the joist of the deck structure. This can cause the deck joist to begin to rot faster over time. Recommend cleaning the joist and applying a penetrating stain to prevent a reoccurrence.

Contact a qualified professional.

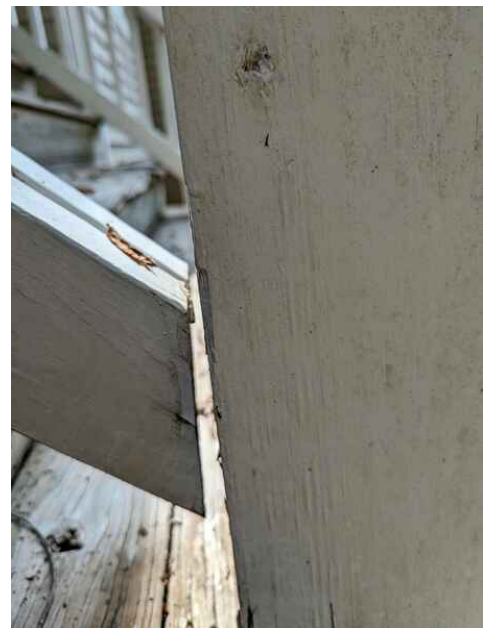
3.9.1 Porch

**GUARDRAILS: LOOSE**

There were not any fasteners attaching the bottom rail of the stair handrail at the time of the inspection. This will cause the railing to be weaker than needed if someone falls into the railing.

Recommend using screws to fasten the railing to the post to secure it.

Contact a qualified professional.

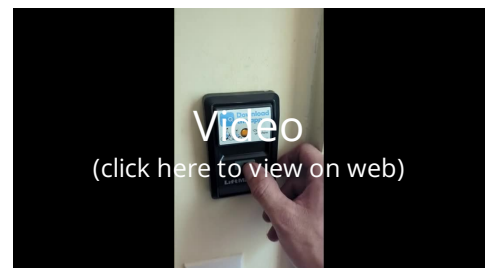
The light on the garage door opener did not operate at the time of inspection. This could be due to the bulb needing replacement or a possible issue with the Opener or Light Switch. Recommend changing the light bulb to see if that corrects the problem.

Contact a qualified professional.

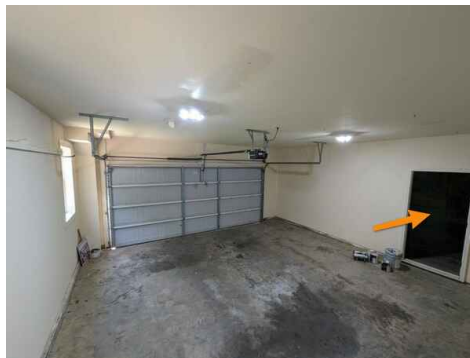
Door into Utility Room does not have a self closing hinge.

The door to the utility room was open at the time of inspection and did not have self closing hinges installed. This can allow the HVAC system to draw in air from the garage which can draw exhaust gases from vehicles to enter the living space and cause a concern for carbon monoxide. Recommend installing self closing hinges on the door to the utility room.

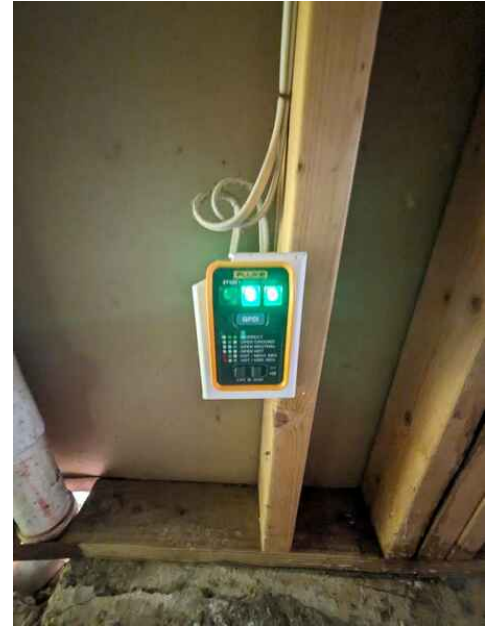
The electrical outlets within the utility room were not GFCI protected at the time of the inspection. As these outlets are located in an open garage close to the floor with the potential to come in contact with water it is recommended that they be GFCI protected to protect for shock hazards. A licensed electrical should be contacted for further evaluation and repair.

Contact a qualified professional.

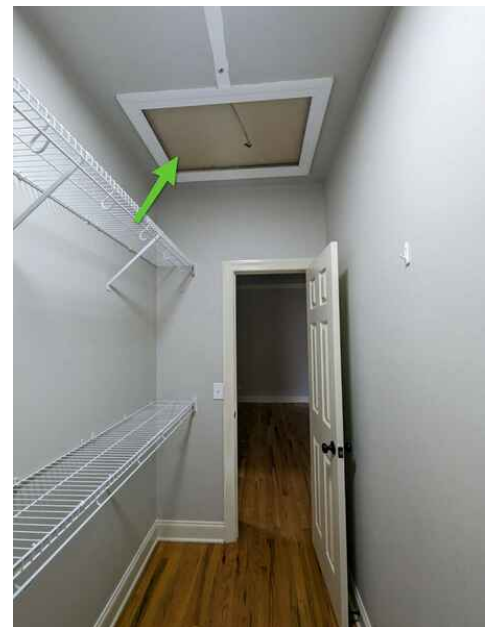
ATTIC ACCESS: LIMITED ACCESS

Blown-in Insulation Depth covered all truss members making it Unsafe to access the entire attic space. Attic was inspected based on what was visible from the access hatch area.

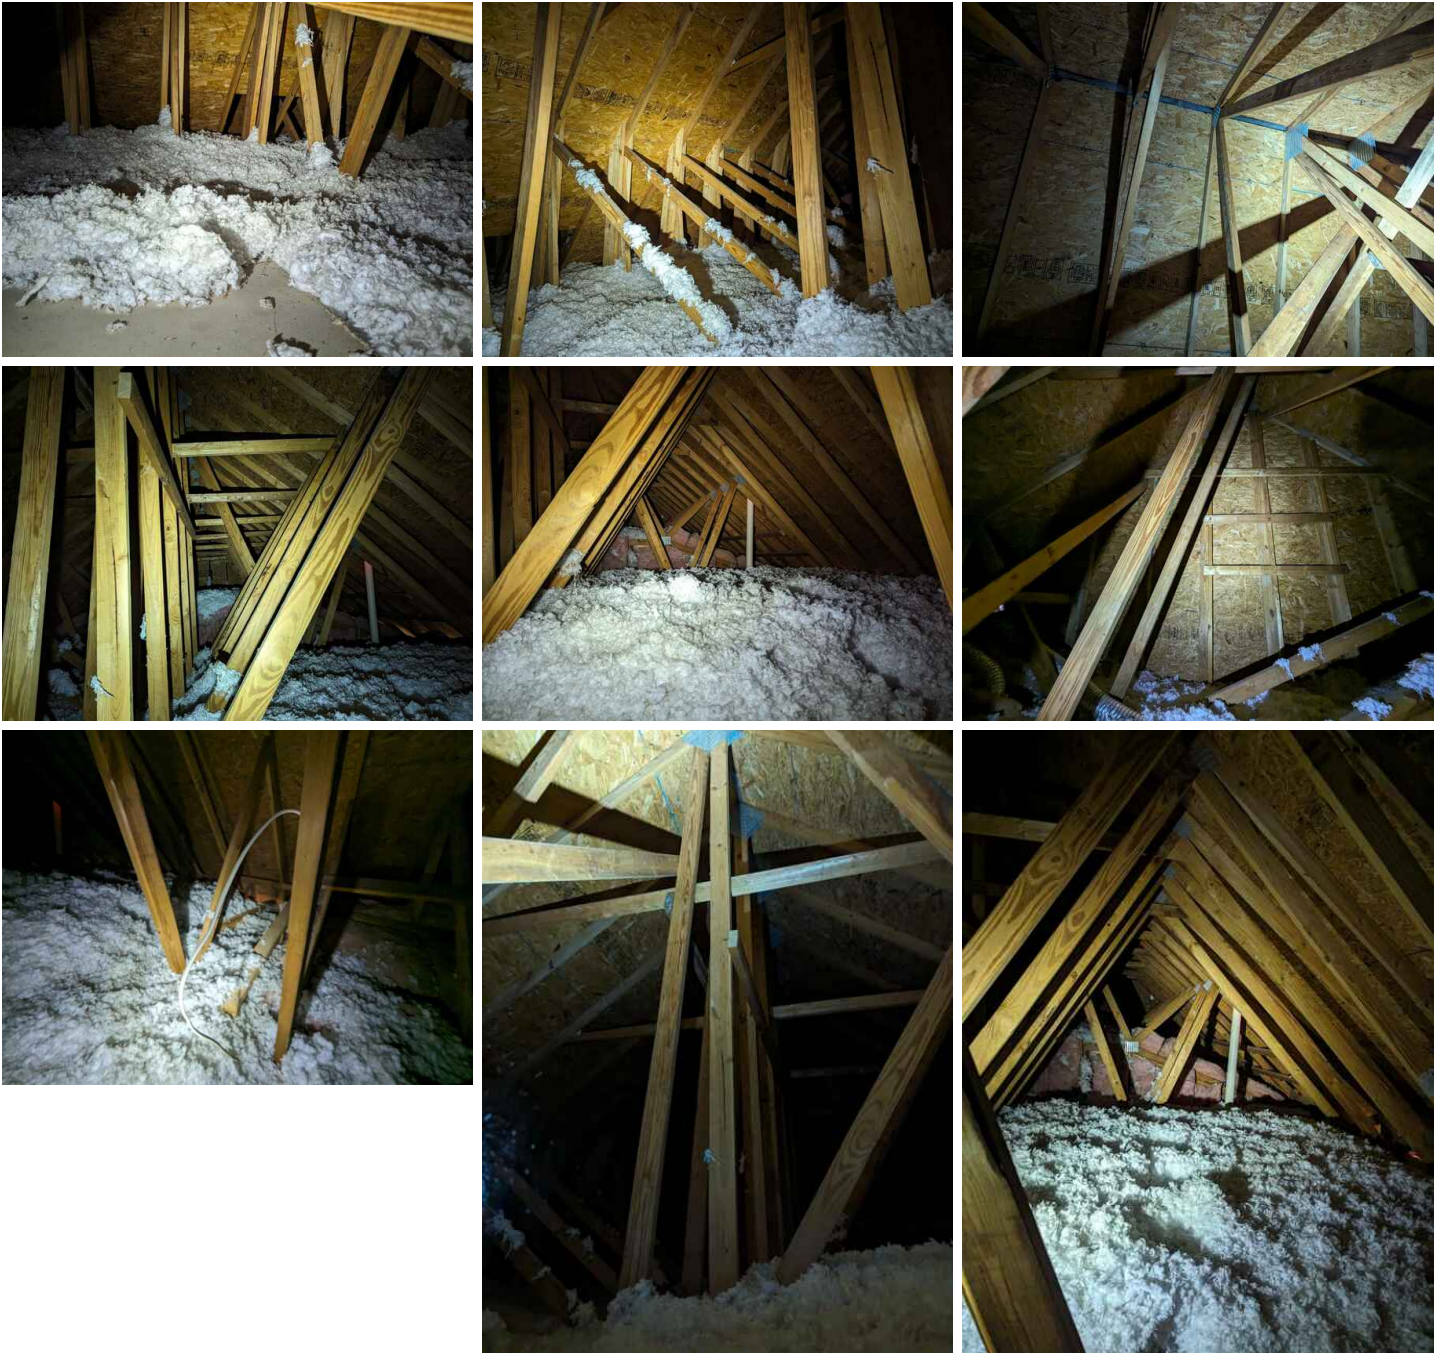
BLOWN IN INSULATION COVERING TRUSS MEMBERS.

Blown in Fiberglass insulation was completely covering the truss members and no walk boards were present at the time of inspection Limiting the scope of the inspection. The attic was inspected from the access hatch and the entire attic space was not visible.

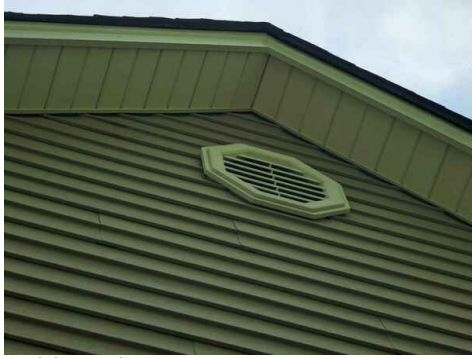
GABLE VENT INACCESSIBLE

The Gable end vent for a portion of the roof/attic ventilation was not visible due to limited access to the attic space. Gable end vent is located at the opposite end of the home to where the attic access is located.

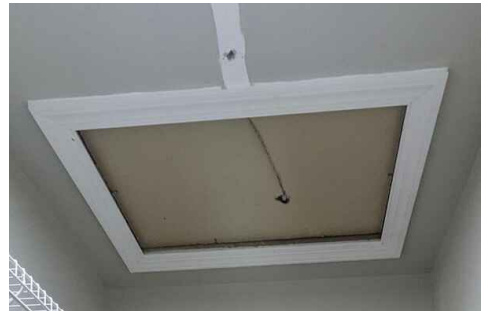
The attic access hatch cover was not insulated. The attic hatch also does not seal completely when in place and allows air to flow between the attic and living space. The Inspector recommends insulating the attic access hatch cover as well as replacing the access hatch with a completely seal version to reduce unwanted heat loss/gain.

Contact a qualified professional.

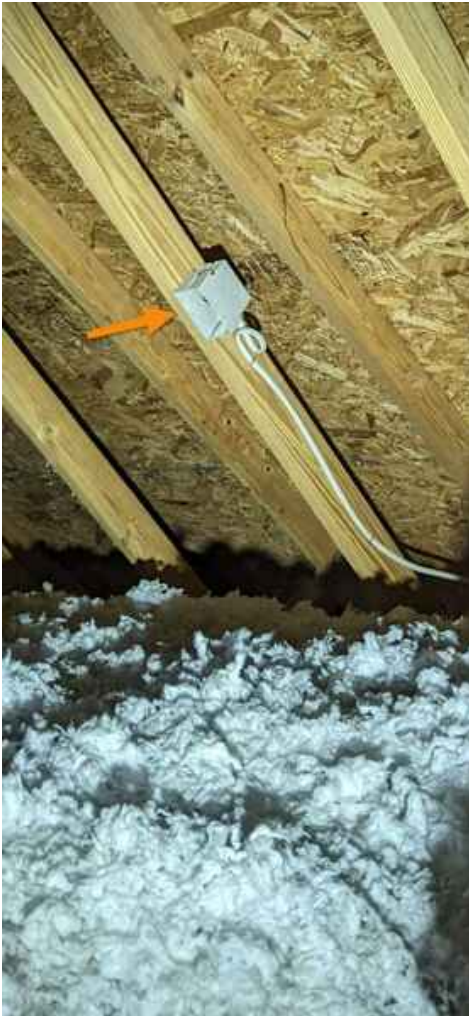
Open Junction Box

Open electrical boxes present a shock hazard from live electrical wires. Inspector Recommends having cover plates installed on any open Electrical boxes.

Contact a qualified electrical contractor.

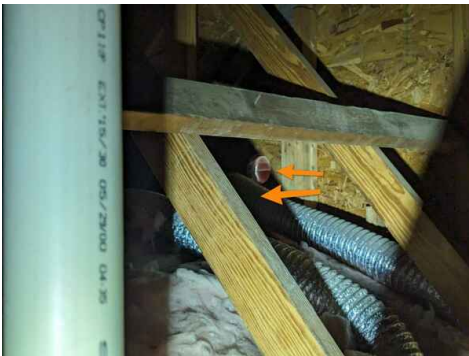
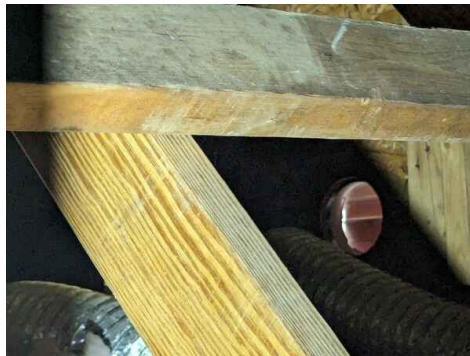
The exhaust vent ducting has come disconnected from the Vent port and was at the time of the inspection exhausting air into the attic space. This can allow warm moist air to collect on the insulation within the attic causing the potential for organic growth. Inspector recommends reconnecting the exhaust vent ducting to prevent further issues.

Contact a qualified professional.

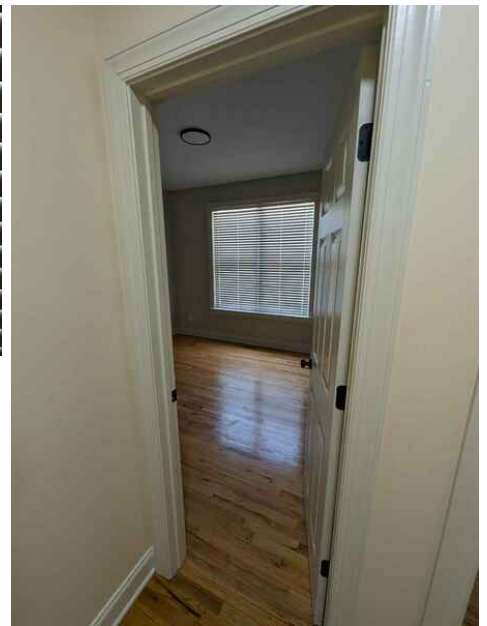
Blind has a crack in it.

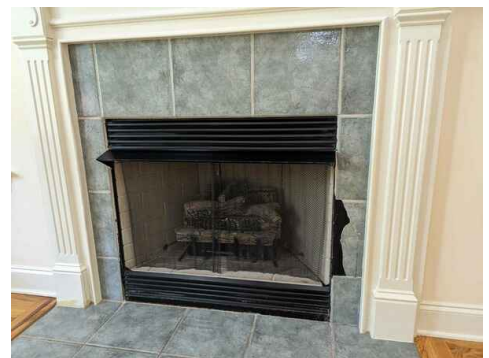
7.10.2 Fireplace

DEBRIS IN FIREPLACE.

The fireplace was not tested during the inspection. Gas was turned off. Recommend cleaning out the Firebox and then testing the equipment.

Flammable debris inside firebox

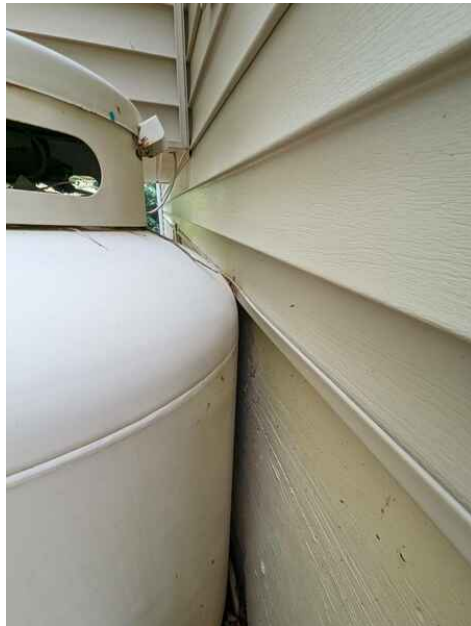
Propane Tank is touching the house.

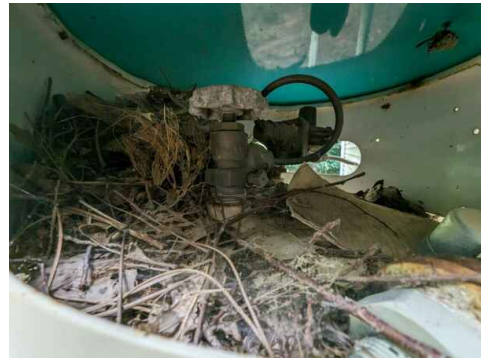
There appears to be a bird nest located inside the lid of the propane tank

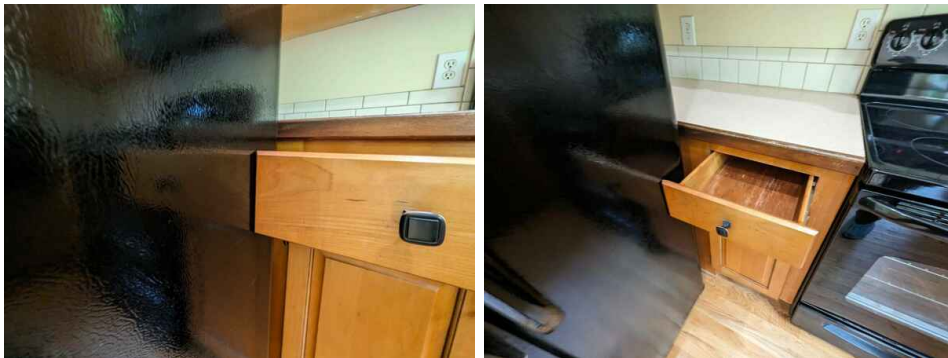
8.2.1 Cabinets

The Drawer closest to the refrigerator contacts the refrigerator door when opening it. Can cause premature wear and tear on the draw over time. Recommend modifying the drawer face to allow it to clear the refrigerator.

Contact a qualified professional.

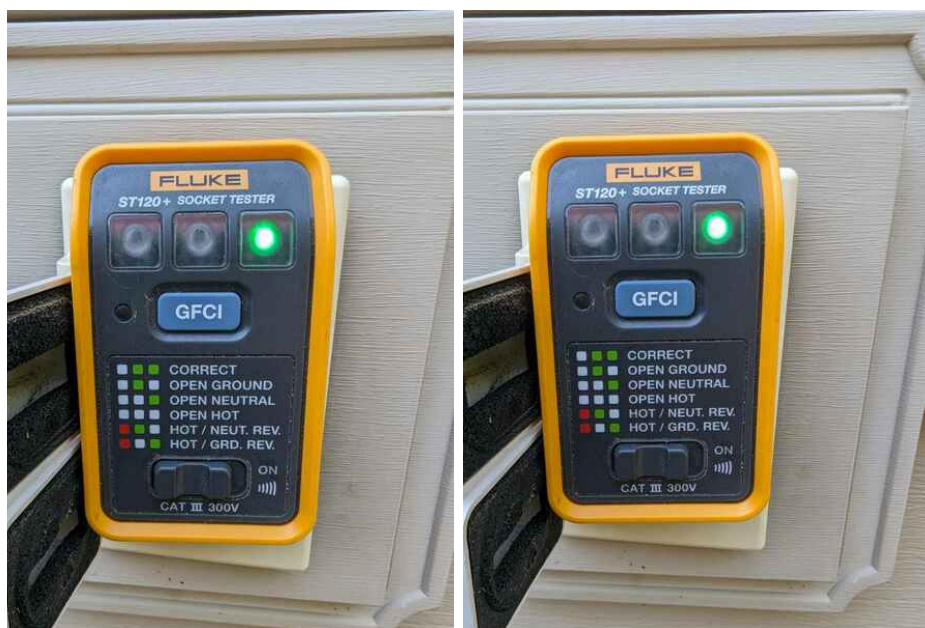
Photo error causes lights to not show up on film on occasion Outlets are wired correctly

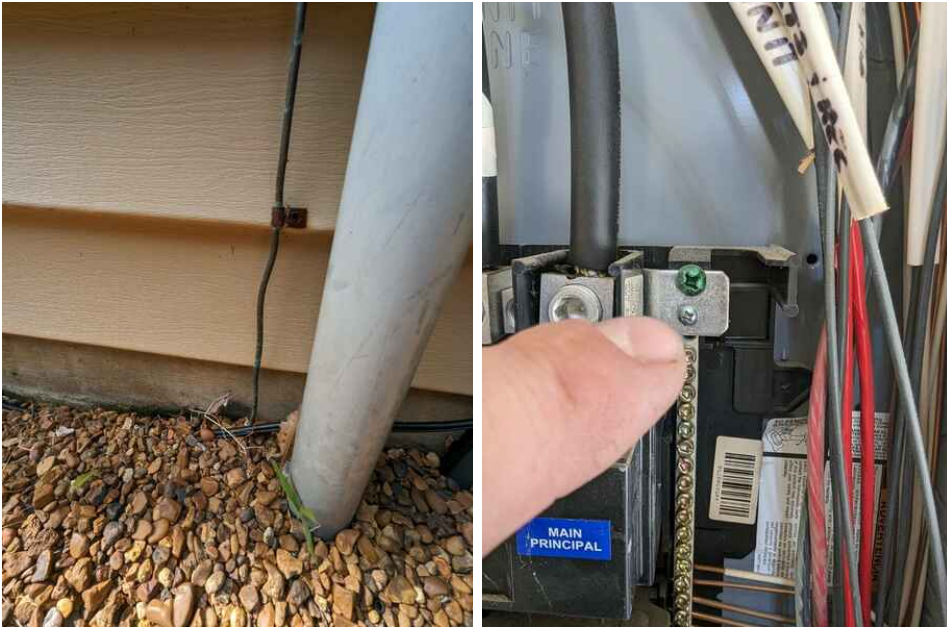
GEC: CONNECTION TO ELECTRODE NOT VISIBLE, RECEPTACLES GROUNDED

The Inspector was unable to visually confirm connection to a grounding electrode. This condition is common because grounding electrodes are required by modern safety standards to be fully buried. Testing of home electrical receptacles indicated connection to a grounding electrode.

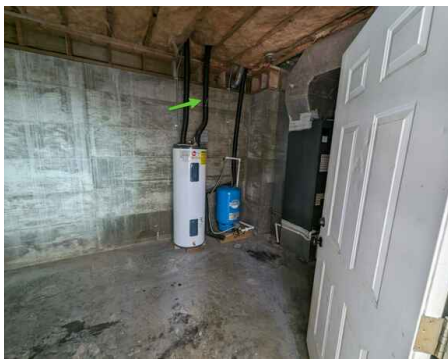
Main Water Shut Off

The main water supply shut-off was located in the Garage Utility Room Above the hot water heater.

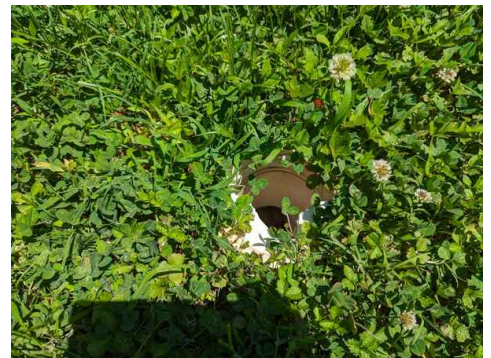
BROKEN CLEANOUT

A broken clean out cap was observed at the right corner of the garage door in the grass. This can cause the DWV to not operate properly as well as allow rodents and debris to clog the system and create a back up into the house. Recommend a licensed plumbing contract to repair the broken cap as soon as possible.

Contact a qualified professional.
